# Comprehensive Vehicle Condition Records

## Toyota CROWN KLUGER

2.5L HEV AWD Prestige

Vehicle Identification Number (VIN) : LFMJD7BN1\*\*\*\*3997

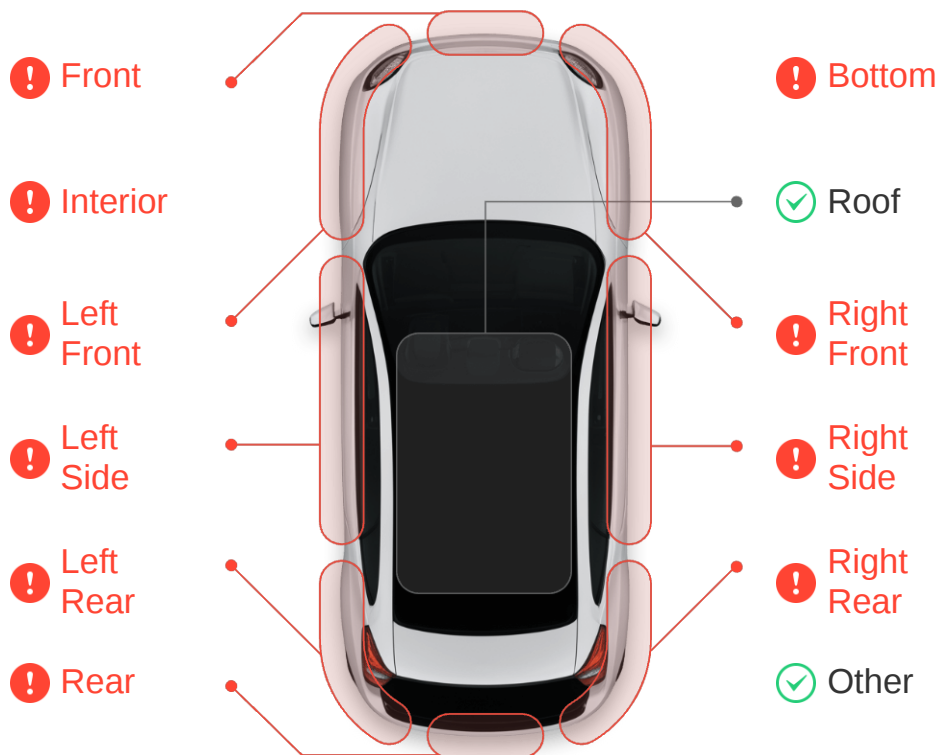
## Vehicle Repair Position Overview

**Airbag :** Replacement,Disassembly and assembly

Safety Impact : Potential safety hazard

Price Impact : Severe

**Right rear longitudinal beam :** Replacement

**Right front beam head :** Replacement

**Right front wheel cowling :** Replacement

**Price Impact : Severe**

**Right front longitudinal beam : Replacement**

**Left rear fender : Replacement,Disassembly and assembly,Painting**

Safety Impact : Safety hazard

Price Impact : Serious

**Left front wheel cowling : Replacement**

**Left front longitudinal beam : Replacement**

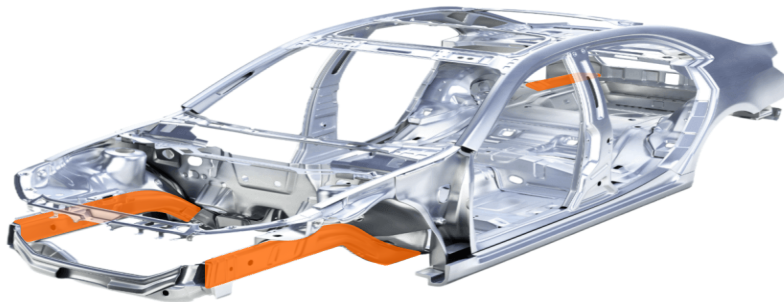
## Frame Part Repair Traces

**Right rear longitudinal beam** : Replacement

Safety Impact : Safety hazard

Price Impact : Severe

**Right front longitudinal beam** : Replacement

**Left front longitudinal beam** : Replacement

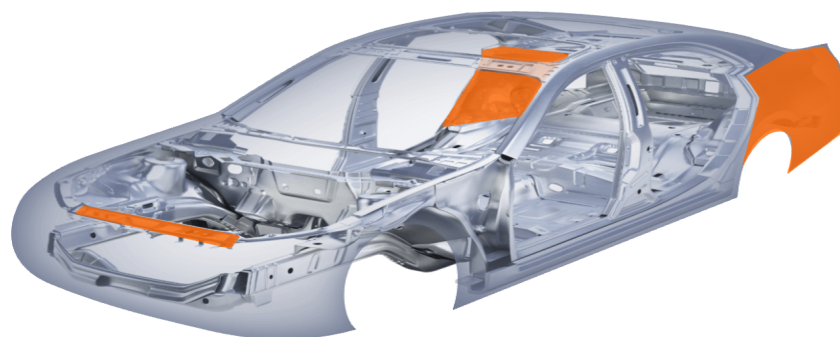
## Reinforcement Part Repair Traces

**Right front wheel cowling :** Replacement

Safety Impact : Potential safety hazard

Price Impact : Severe

**Left rear fender :** Replacement,Disassembly and assembly,Painting

**Left front wheel cowling :** Replacement

**Radiator frame :** Replacement,Disassembly and assembly

Safety Impact : No impact

Price Impact : Significant

**Right rear fender :** Painting

Price Impact : Minor
